## COMPUTER SETUP INSTRUCTIONS

## PANORAMIC DENTAL IMAGING

### Computer & Software Setup Instructions

for a computer with Windows 10 Professional 64-bit

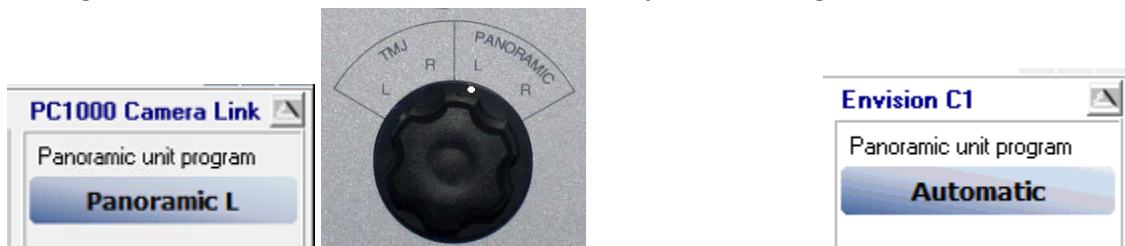
- a. Ensure the Software direction L/R (top right of screen) matches the Machine direction L/R (side panel)  
A green connection to the software/sensor is required to change this button direction

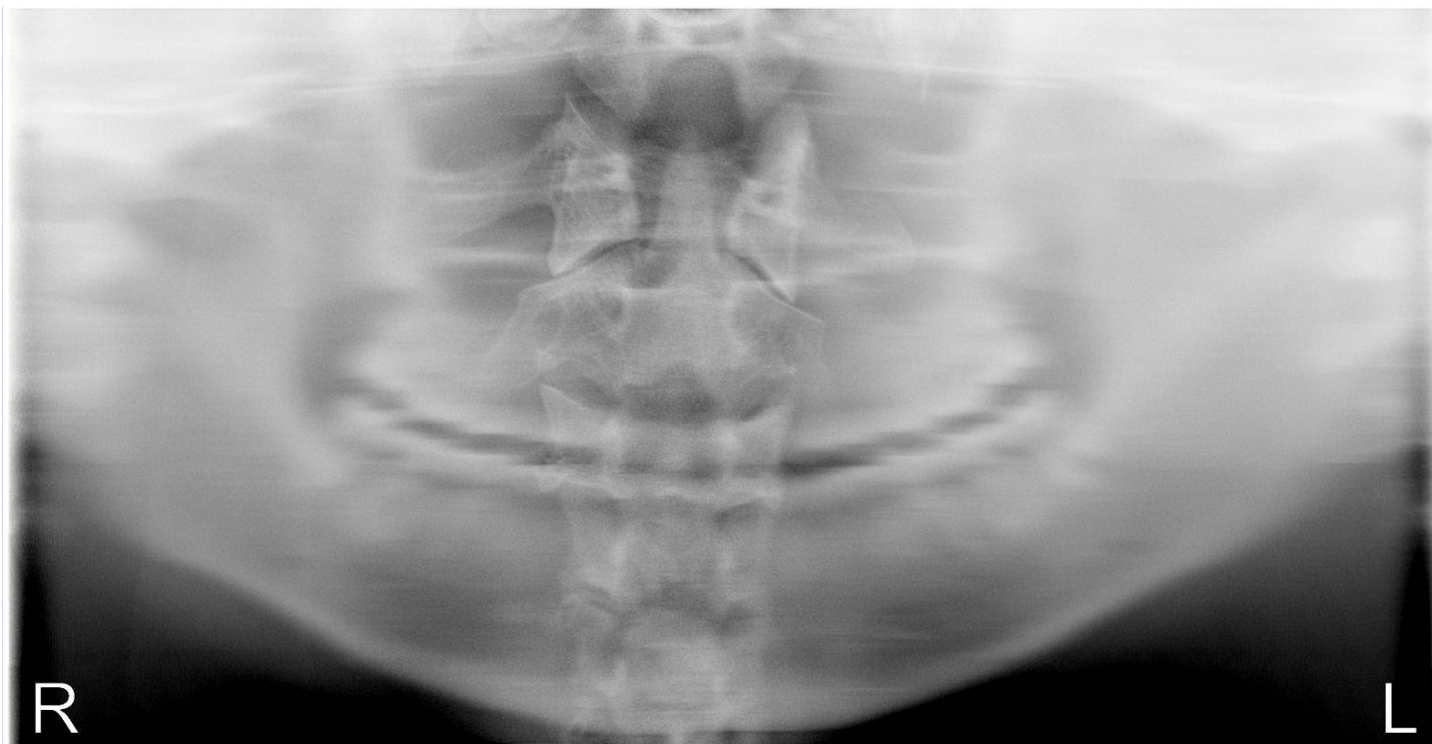
How to Correct VERY blurry images from using the wrong direction captured

Only for PC1000 & PC4000 units.

**Reason for the Problem:** The direction of the machine capture did not match the Software. Change the button in the software by clicking on it, or change the machine direction to match.

**To Correct the image to avoid a retake:** Recover the image by using the Data repository under the File menu. Once the poor image is reloaded, then flip the dataset direction by using the Tools menu. You may correct the image first if it is still on the screen

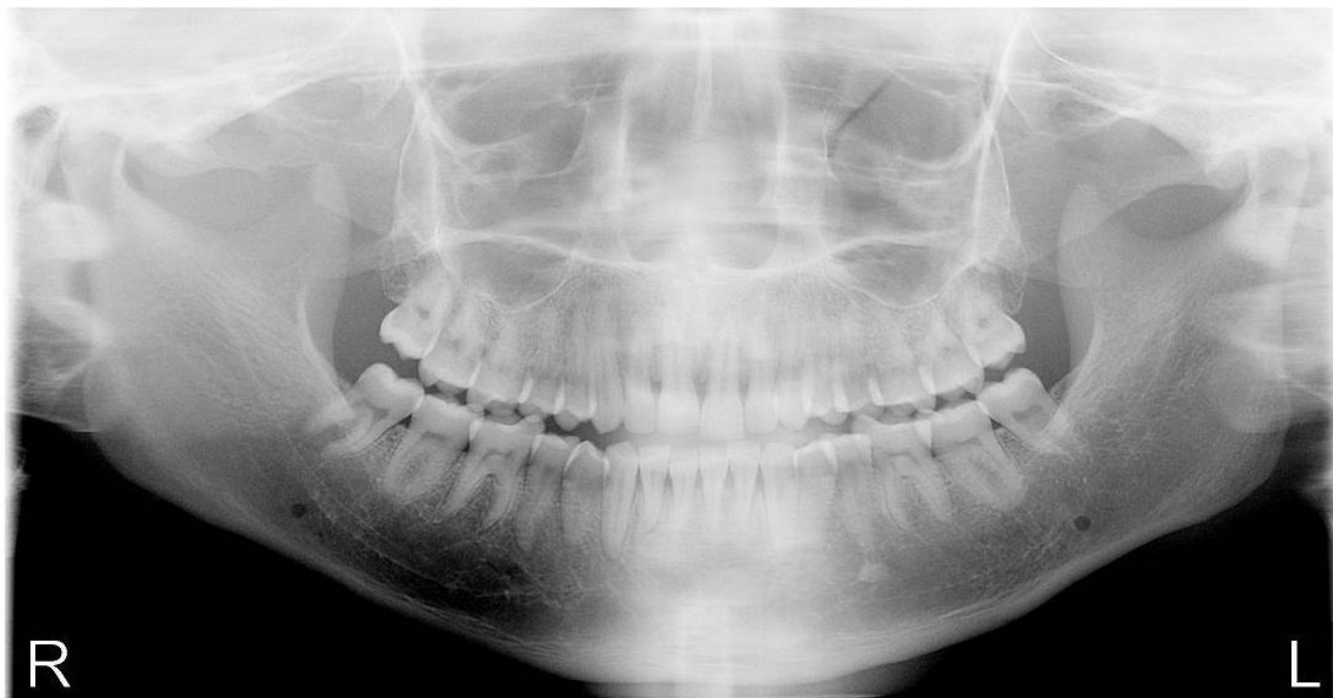
Below is an example when using the Equal Vertical tool.

Before the Equal Vertical tool is used:

Description: The Equal Vertical tools will equalize the columns in the image. This should be the first tool used after taking a panoramic x-ray. For example, the center of the image is generally lighter because of the spinal shadow due to the position of the patient. To help minimize this “shadow” of the spine in the image, using the tool will darken the middle and lighten the sides, balancing the difference in darkness across the image.

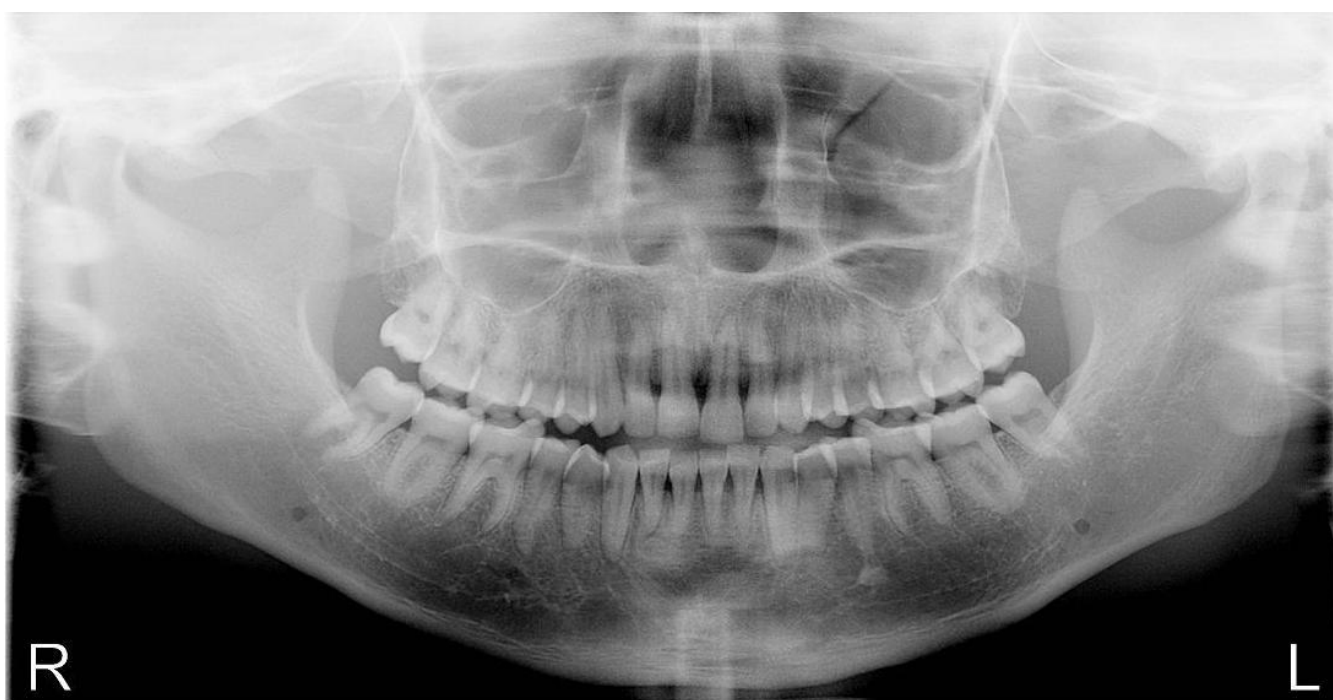
After the Equal Vertical tool is used:

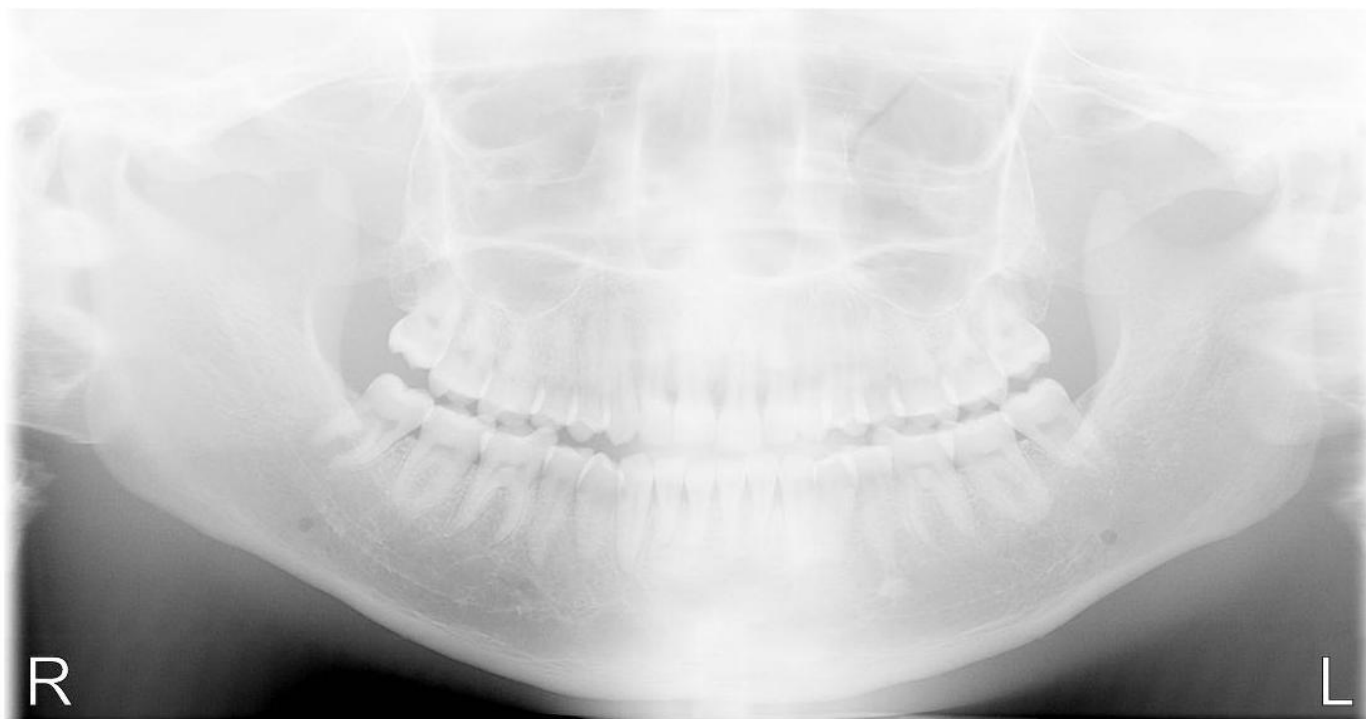
Below is an example when using the Histogram (or Image controls) tool.

Before the Histogram tool is used:

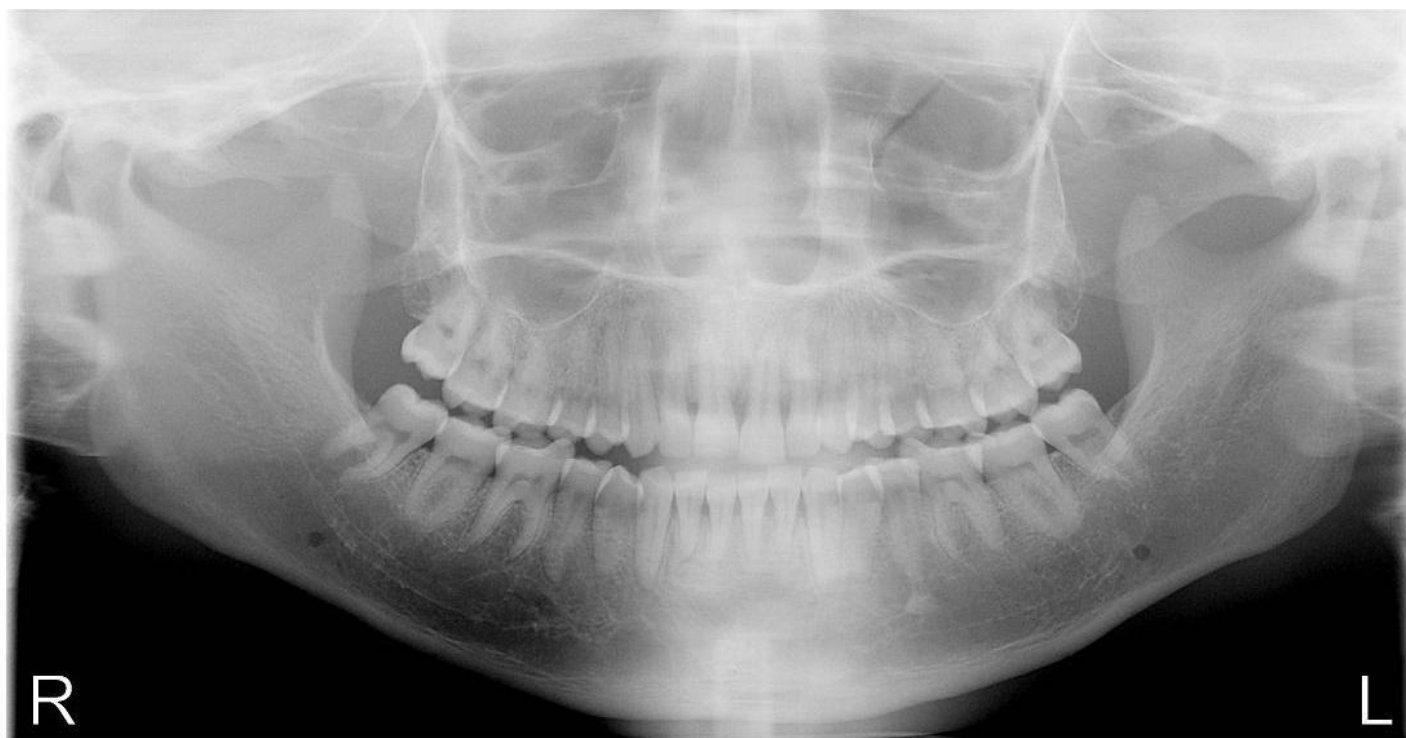
After the Histogram tool is used:

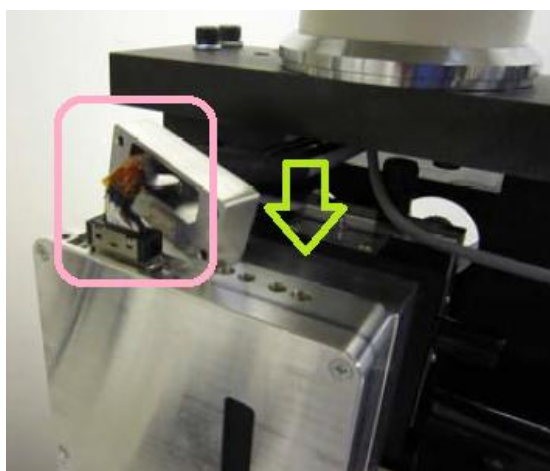
The **Blue** arrow below is the other end to the power cable to the sensor.

The **Purple** arrow is the 'trigger' which tells the software its exposing.

The **Pink** arrow is where the datacable connector is. (Typically without the metal rectangular cover)

The **GREEN** arrow below points to the Sensor Power GREEN LED LIGHT. (Independent of the software connection)
